### Motor Bearing Currents

The use of variable speed drives with ac motors induces electrical currents on the motor shaft. In a small fraction of electric motor applications this can lead to premature bearing failure! In this article we will learn (a) How to recognize this problem and (b) what are the possible solutions to this problem and finally (c) what I think is the best of the most recent solutions.

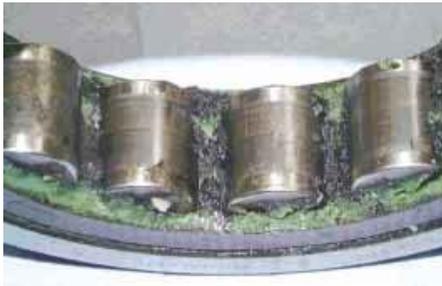
Black discolored grease affected by current discharges

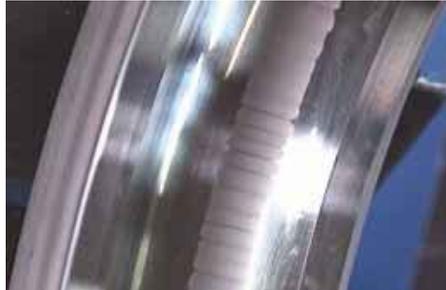
Fluting or washboard in raceway

**Fluting** occurs when the operational frequency of the VFD (Variable Frequency Drive) causes concentrated pitting at regular intervals along the bearing race wall, forming a washboard pattern. This pattern results in vibration and noise and in a HVAC system can be transmitted throughout a facility via the air ducts.

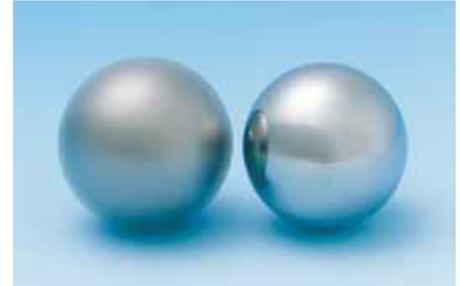
The dull surface of the ball is a sign of micro-cratering called **frosting**

**Frosting** is a name given to the damage caused by electrical discharge fusion craters. This damage begins as pitting and these fusion craters increase in number and size as each cycle of induced voltage discharges through the bearings to the frame and ground. Soon the entire race is covered with millions of pits. As new fusion craters form over old ones, eventually a "frosted" surface visible to the naked eye appears.

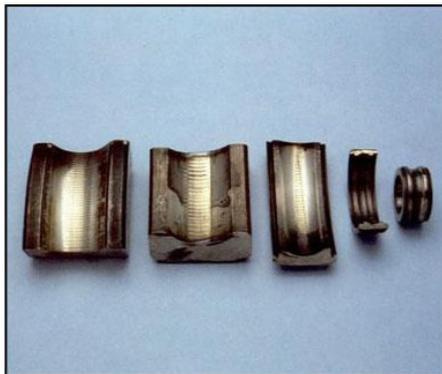
Electrical currents that pass through a bearing cause small pits to be burned into the bearing races. This can form a pattern known as "**fluting**" which is shown in the photograph

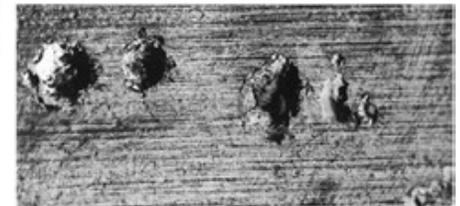
Fusion craters in a bearing race from Scanning Electron Microscope image

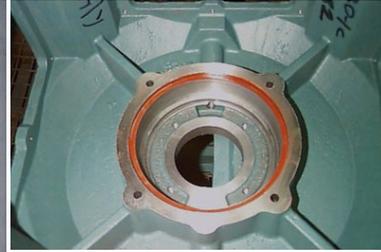
Insulated bearing.

The bearings can be insulated using bearings and sleeves as per the photos above.

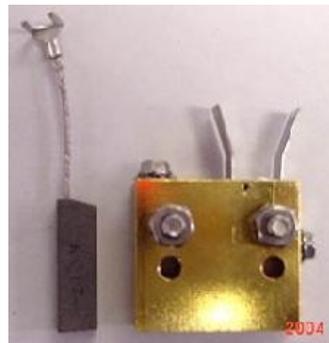
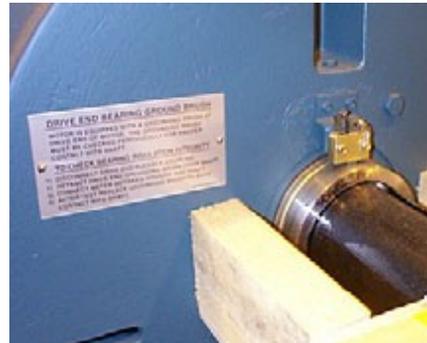
**4. Diverting away the harmful bearing currents.** This can be accomplished by the use of a suitable shaft grounding brush(es) or by the use of conductive microfiber shaft grounding ring(s).

A metal brush contacting the motor shaft is a more practical and economical way to provide a low-impedance path to ground, especially for larger NEMA-frame motors. However, these brushes pose several problems of their own:

- a. They are subject to wear because of the mechanical contact with the shaft.
- b. They collect contaminants on their metal bristles, which destroys their effectiveness.
- c. They are subject to oxidation buildup, which decreases their grounding effectiveness.
- d. They require maintenance on a regular basis, increasing their cost.
